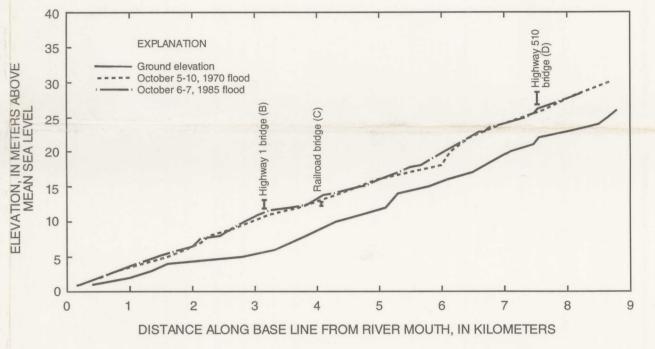
Figure 4. Flood profiles for the Río Jacaguas, Puerto Rico.

5-10, 1970, and October 6-7, 1985, are shown in figures 3 through 7. Although the flood of 1985 was larger than the 1970 flood, in some areas the water-surface elevations were higher during the 1970 flood than during the 1985 flood.
